Service information

Reference no.: GDA_111060

Alarm Empty Drip Tray on: families involved are XELSIS, INCANTO EXEC, EXPRELIA, EXPRELIA EVO.

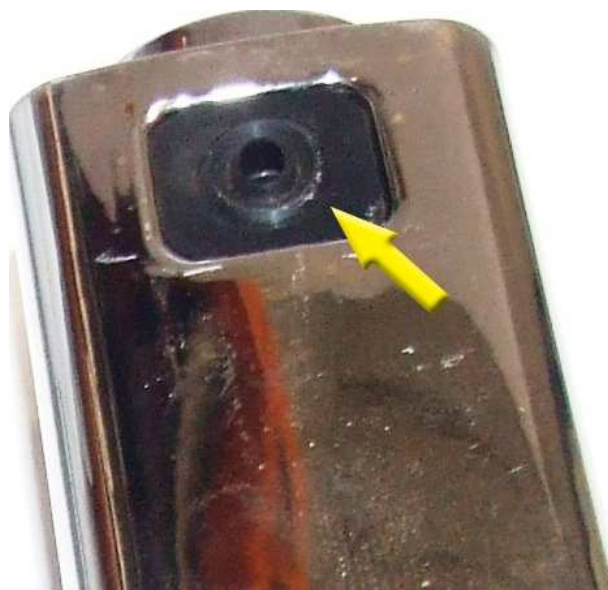
You may experience a product leakage that is poured into the dispenser inside the door where the water sensor is positioned, causing the alarm "EMPTY DRIP TRAY" even if it's empty.

Order the part number 421944057391 BLK COF.DISPENS.SEAL V2 MYB9. It's a seal,(Image1), inserted on the machines from s.n. TU901525074781 to avoid the leakage.
(Image1)
