**Service information**

**Reference no.: SDA\_100186**

Brew unit is hard to remove

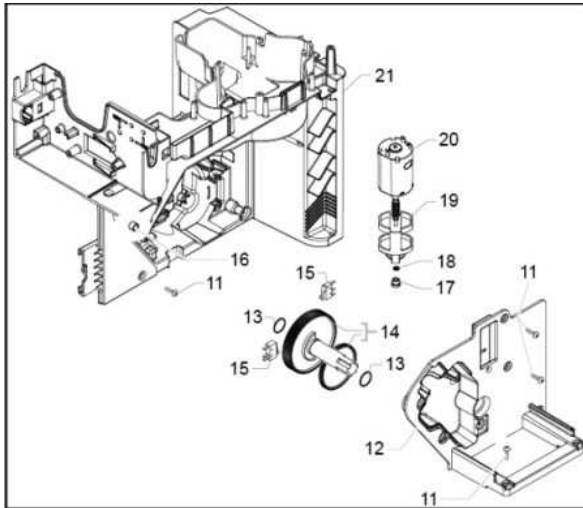
The customer complain that the brew unit is hard to remove. It can happen that while removing the brew unit, parts of the brew unit or the holder can be broken.

Up to S/N TW901326365961 change the black ratiomotor mounting plate cover with a new one (part N°12 in Image 1 cod.996530073444 - 17001839).

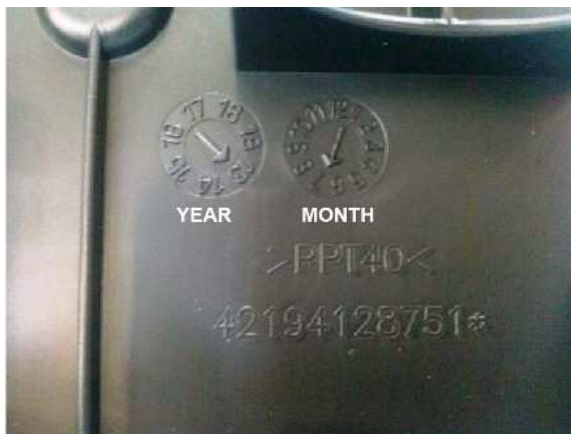
From S/N TW901326365962 the black ratiomotor mounting plate cover has been modified to improve the inserting and the removing of brew unit.

In Image 2 the detail of production date of modified part.
