Service information

Reference no.: SDA_102379

NEW WATER CONTAINER

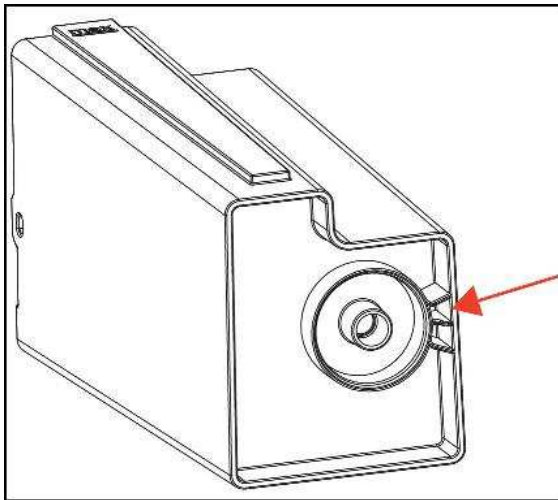
Image 1

INFO:
Flood of water from the bottom of the appliance while inserting the tank due to the customer.

CURE:
En case of the flood of water from the bottom of the appliance while inserting the tank, replace the old water thank with a new code 421941302721.
In the new water thank has been added 3 centering ribs beside a water thank valve (see Image 1).
