Service information

Reference no.: SDA_103810

Mandatory: Insert instruction sheet for milk carafe

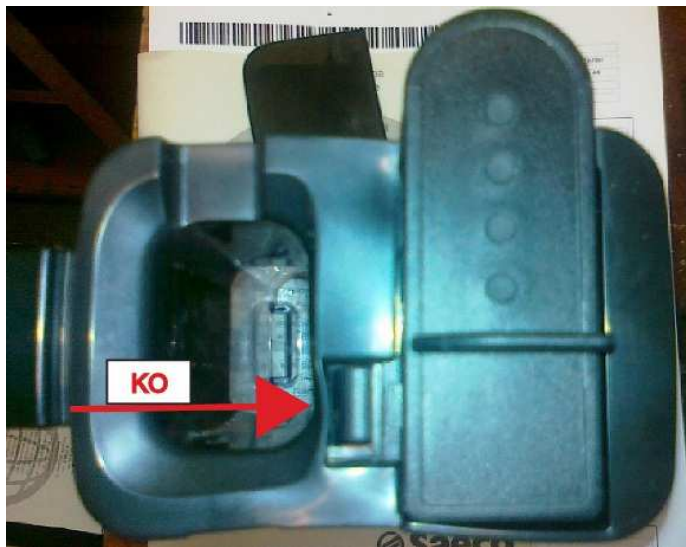
Image 1

The upper cover part of the milk carafe can be deformed during the milk production by a spillage of steam coming out from the proper path if the slide is not moved completely in the correct position. The problem is caused by an incorrect use of the milk carafe by the customer. The Images 1 and 2 show the cover deformed and the one not deformed.

In all machines that return to workshop for any reason up to serial numbers indicated, insert the additional sheet, code 421944025201 that you find in the attached file.
