Service information

Reference no.: SDA_104540

GC92xx Power PCBA and Button Panel Assy compatibility issue

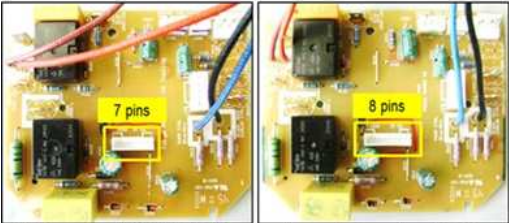
Old Power board PCBA with 7-pin connector

Improved Power board PCBA with 8-pin connector

Root causes: Old power board PCBA and button panel assy have 7-pin connectors. The new parts have 8-pin connectors. It is not possible to mix old and new parts due to the different pin connectors.

Return set PerfectCare Expert GC92xx	Repair Options	Service Code to order
If Power Board PCBA is 7-pin connector version	<u>Option 1</u> Replace Power Board PCBA and Button Panel Assy	Pos 60: 423902177331 Power Board PCBA (8-pin connector) Pos 51: 423902170311 Button Panel Assy (8-pin connector)

Symptom Cure: When replacing either power board PCBA or button panel assy, both parts must be replaced together if needed, for connector compatibility.
