Service information

Reference no.: SDA_104920

GC76xx No Steam

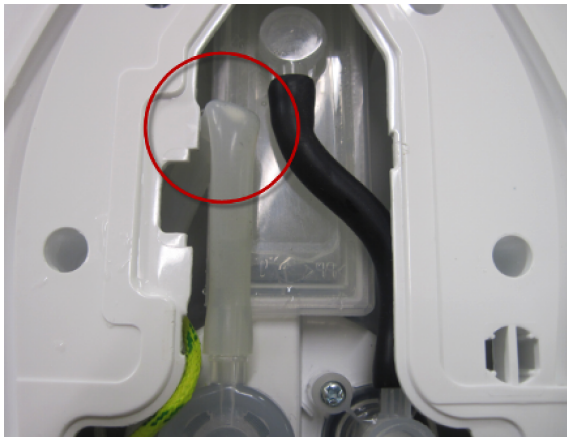
Scenario 1: Pump inlet water tube kinked

Repair action: To re-press the water tube such that the kink portion is straightened.

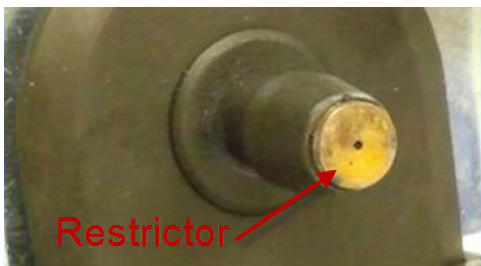
Scenario 2: Pump inlet restrictor blocked

Repair action: If possible, use a sharp object to remove the foreign material blocking the restrictor opening. Otherwise, replace the pump assy (Position 16: 4239 021 81341 for GC76xx except GC7610; 4239 021 76211 for GC7610)
