Service information

Reference no.: SDA_105510

Improvement of the gap between the side panel and the front panel on Granbaristo

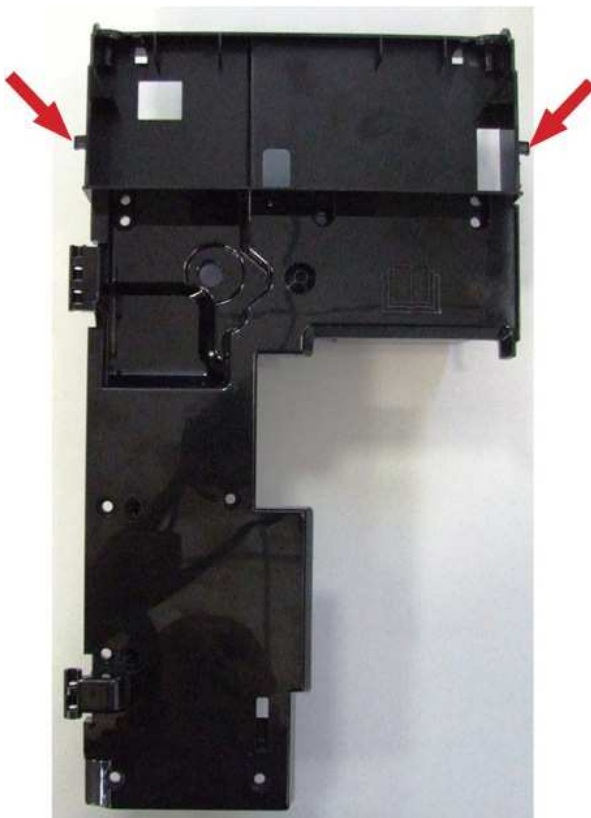
The display support was changed by inserting two hooks to improve the gap between the side panel and the front panel. See Picture 1
