Service information

Reference no.: SDA_106616

Minuto: the BU is difficult to reinsert

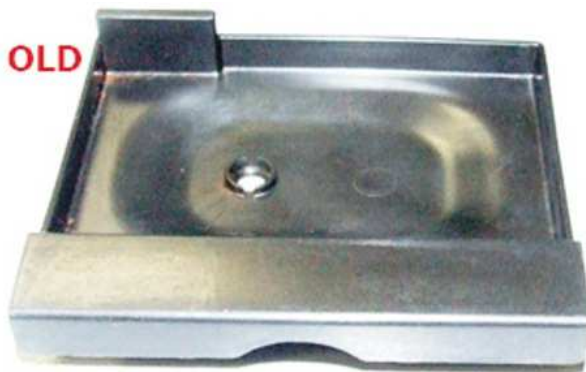
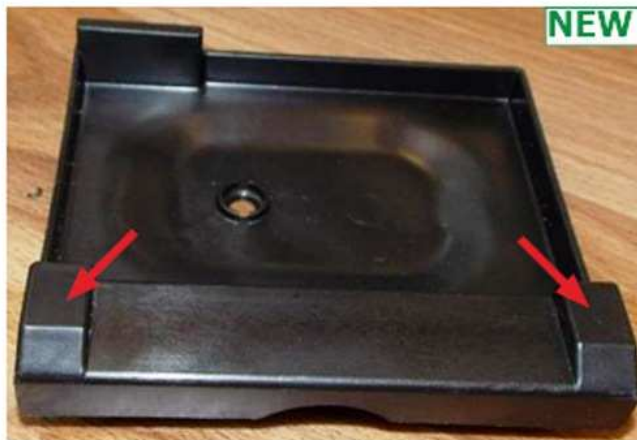
image1

The coffee residues drawer has been improved in order to facilitate the insertion of the Brew Unit into the machine.

From sn TW901425363901, to facilitate the slide and the clamping of the BU into the appliance, the coffee residues drawer (12NC 421944008911) has been improved by adding two ramps on it (Image 1) .
