Service information

Reference no.: SDA_108288

MANDATORY ACTION: GC86xx, GC92xx, GC95xx "hot" handle with water leakage on the side of soleplate

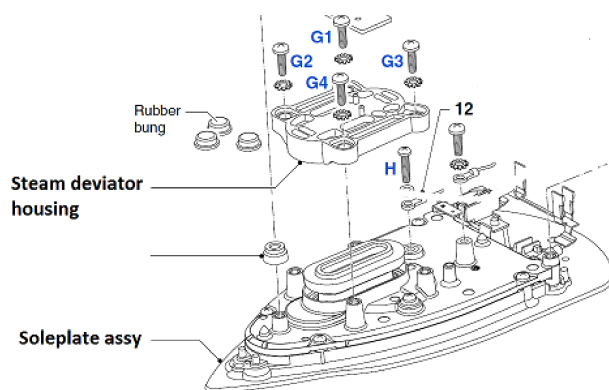
The "hot" handle and water leakage from the side of soleplate could be related to steam leakage within the iron. One potential root cause could be steam deviator housing degradation.

Please replace the soleplate assy together with the steam deviator housing.
Please send back the exchanged parts to your local Philips Consumer Care team / Service Network Manager so that they can forward the parts to Singapore Innovation Site.
