Service information

Reference no.: SDA_108983

Coffee powder inside the service door in the Minuto family

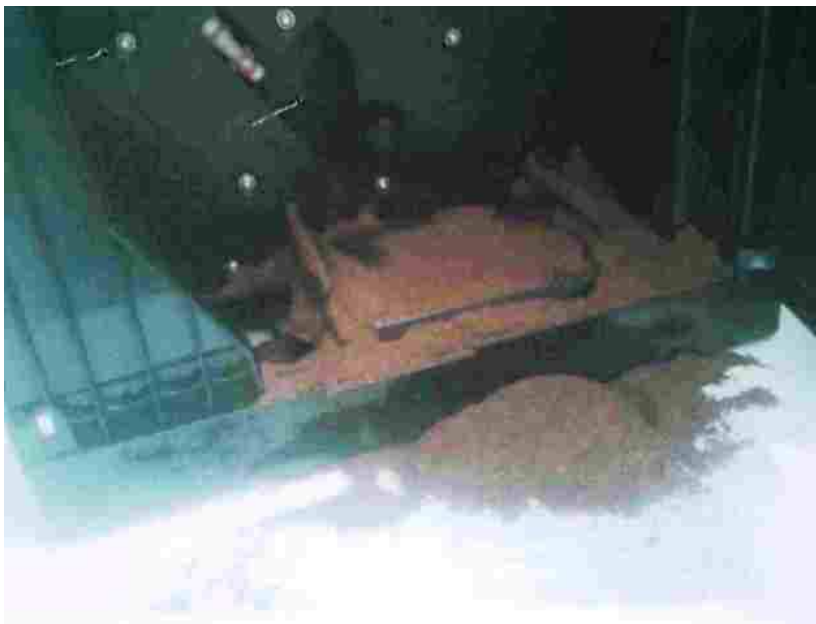
INFO:
Too much powder under the brew unit could be detected (image A)
(image A)
