**Service information**

**Reference no.:** SDA\_108989

Standby button without function in Minuto Family.

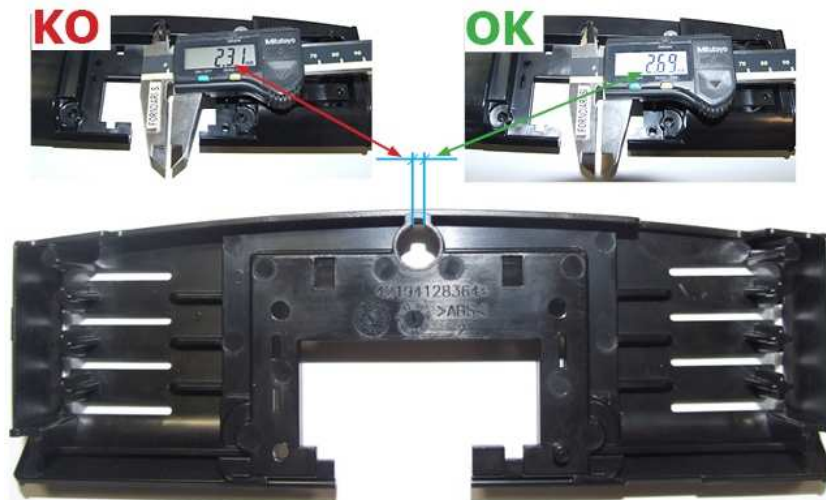
**INFO:**In the display support the tolerance of the standby-button hole can interfere with the button and can create a blockage (Image 1). The tolerance's chain of the stand-by button and black display support components can create the issue whenever the dimension of one component interfere with the dimension of the other part. (Image1)

**CURE:**  
Replace the BLK DISPLAY SUPPORT V2 SMR/H-P-T ASSY.. Cod. 421944017321 with date "13" picture 2 with particular modified date "14" (Image2)  
(Image2)
