Service information

Reference no.: SDA_109326

Main Switch sparking during switching in Minuto.

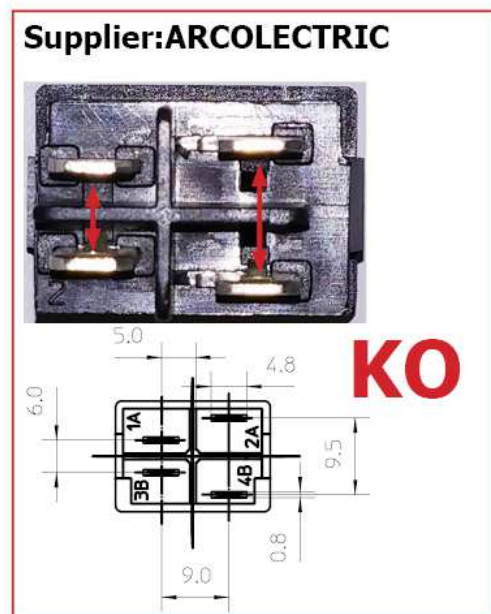
Image1

The defect is caused by a bad component supplied by Arcoelectric supplier.

Repair the appliance by using the SWITCH GENERAL BIPOLAR 1 / 0 cod. 242212625104 Supplied from a different supplier than the ARCOLECTRIC o (Image1)

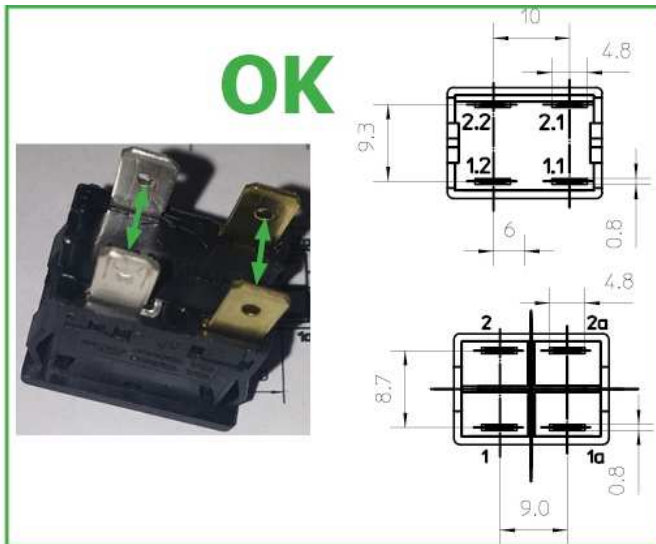
Image2

SWITCH GENERAL BIPOLAR 1 / 0 cod. 242212625104 (same code) supplied by other suppliers than ARCOLECTRIC can be identified because they have the same faston interaxes (with or without the plastic cross between contacts). (Image2)

Any stock of the SWITCH GENERAL BIPOLAR I / 0 Supplier ARCOLECTRIC must be scrapped.
