Service information

Reference no.: SDA_109572

Brew-stop functionality not working

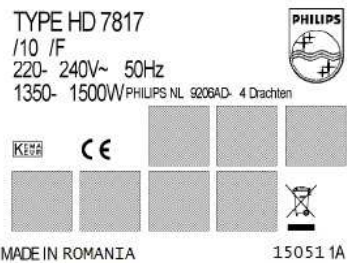
Typelable example:

By accident in **WK1505** the **Romanian** production of the new Senseo II HD7817 models has not been equipped with the Brew Stop functionality. Most likely only the BNL area has received this batch of appliances, but due to grey import, also DACH and French Service Centers can receive this issue.

Any set returned to service, produced in **WK1505 in Romania**, needs to be replaced by a new set. Before exchanging the appliance please check if the appliance really does not have the brew stop functionality, as a part of the infected batch has been reworked in the warehouse.
