Service information

Reference no.: SDA_109733

GC66xx Insulation base repair issue

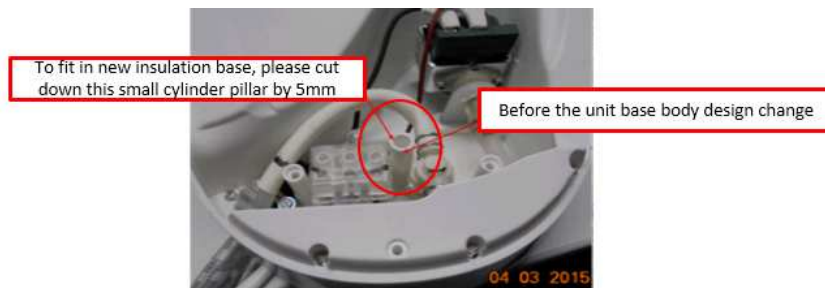
Service center technicians found that the insulation base (pos: 55) is unable to be fit into unit base body (pos:43) during repair.

There was a design change on the unit base body (pos: 43) to exclude the small cylinder pillar (photo as per attached), and Insulation base (pos:55) was subsequently changed to fit into the set in July 2014.

Service center technicians to cut down the plastic for 5mm, and then the insulation base service part will be able to fit into the unit base body.

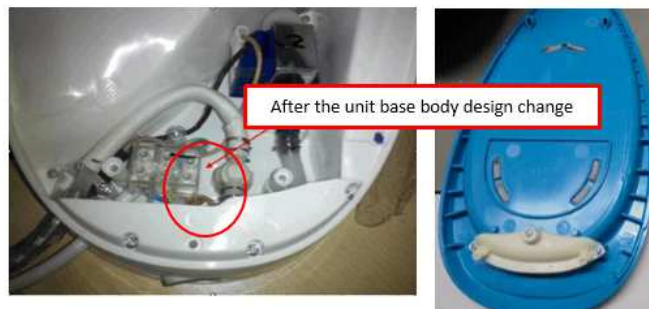
After design change on the unit base body (small cylinder pillar removed) on the left and insulation base after design change on the right.
