Service information

Reference no.: SDA_109796

GC76xx Restrictor choked issue

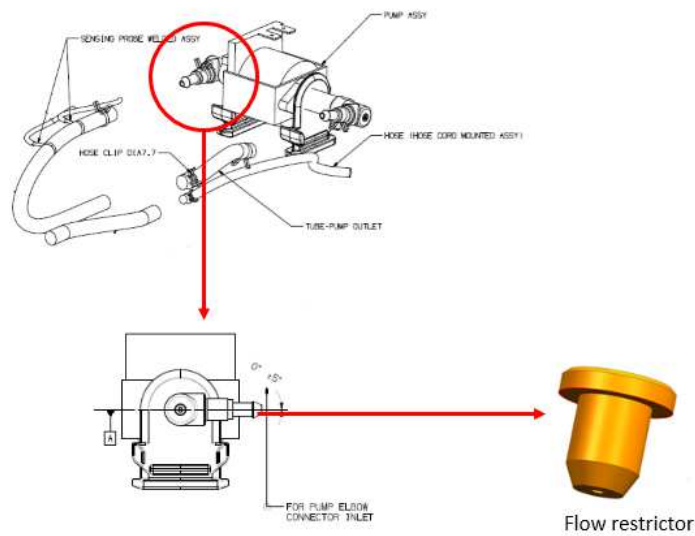
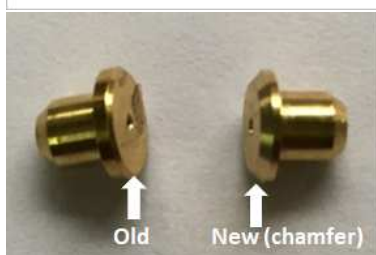
Flow restrictor position:

Symptom:
Consumer experiences low/no steam during ironing

Root causes:
A layer of deposit is formed inside the flow restrictor due to chemical reactions between the water and flow restrictor material

Service center mandatory action:
Please replace the existing flow restrictor with an improved flow restrictor (Pos.35 in service manual, service part 12NC: 423901013294) for all GC76xx market returns with production date code before wk 1514. GC76xx with production date code wk1514 and after are all assembled with improved flow restrictor.
