**Service information**

**Reference no.:** SDA\_110195

Mandatory action: Replace boiler pin connector in all repairs for Minuto family.

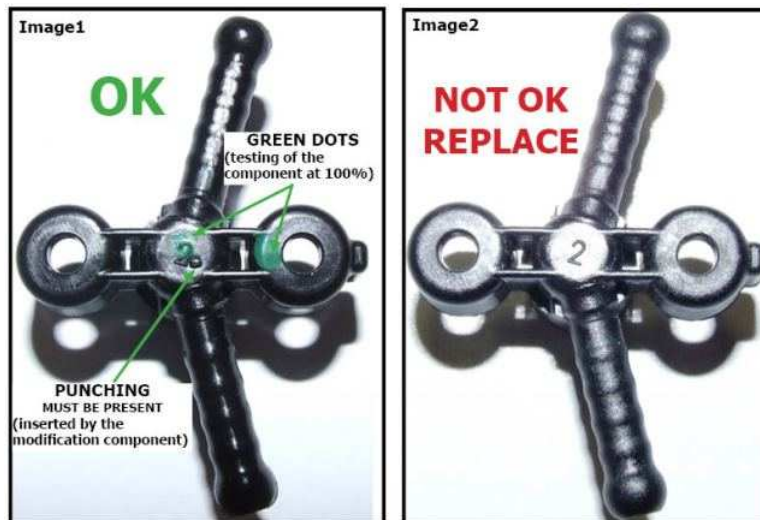
Visual identification of improved connector is possible by the punching on the connector (see image1). All improved connectors will have the visible and tangible punching and two green dots

Code: 421941279742 BLK CONNECTOR FOR PIN BOILER V2 SMR (see image 1)

- 1) In all Minuto machines up to week 13/2015 replace the boiler pin connector by the improved version.
- 2) In case you have stock of the old connector, do not use these any more for repair.  
The spare parts order desk will contact you for taking the appropriate action.

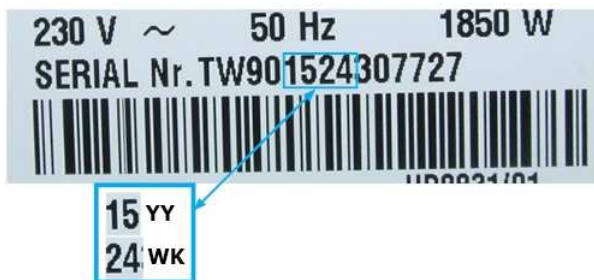
(Image 3)

From week 14/2015 the boiler pin connector was improved to avoid leakage (SN relation to production week: image3)
