Service information

Reference no.: SDA_110567

MANDATORY ACTION: GC96xx Soleplate leaking water

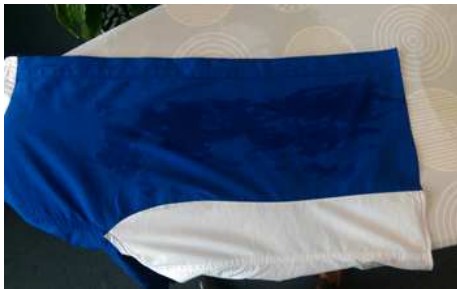
User experiences leaking from soleplate during ironing. Refer photo below.

This is likely to happen upon the second ironing session whereby the earlier session ended with appliance being stored with water left in the water tank. This would not happen if the appliance was stored with an empty tank.

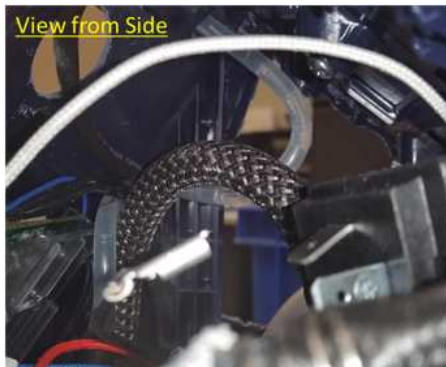
View from Side

Pump assy de-air tube inside the appliance was folded during assembly.

When the appliance cooled down, the boiler inside the appliance would suck water from the water tank instead of air since de-air path was blocked by the folded tube.

Boiler would be overfilled with water which resulted in water running out of the soleplate during steaming.

Kinked de-air tube observed

Empty the water in the boiler via the Easy Rinse knob. Caution: Ensure to cool down the appliance completely, at least 2 hours, before opening the Easy Rinse knob.

De-kink the folded de-air tube.
