Service information

Reference no.: SDA_111874

Minuto family. The alarm message of the door/drip tray pops up unexpectedly.

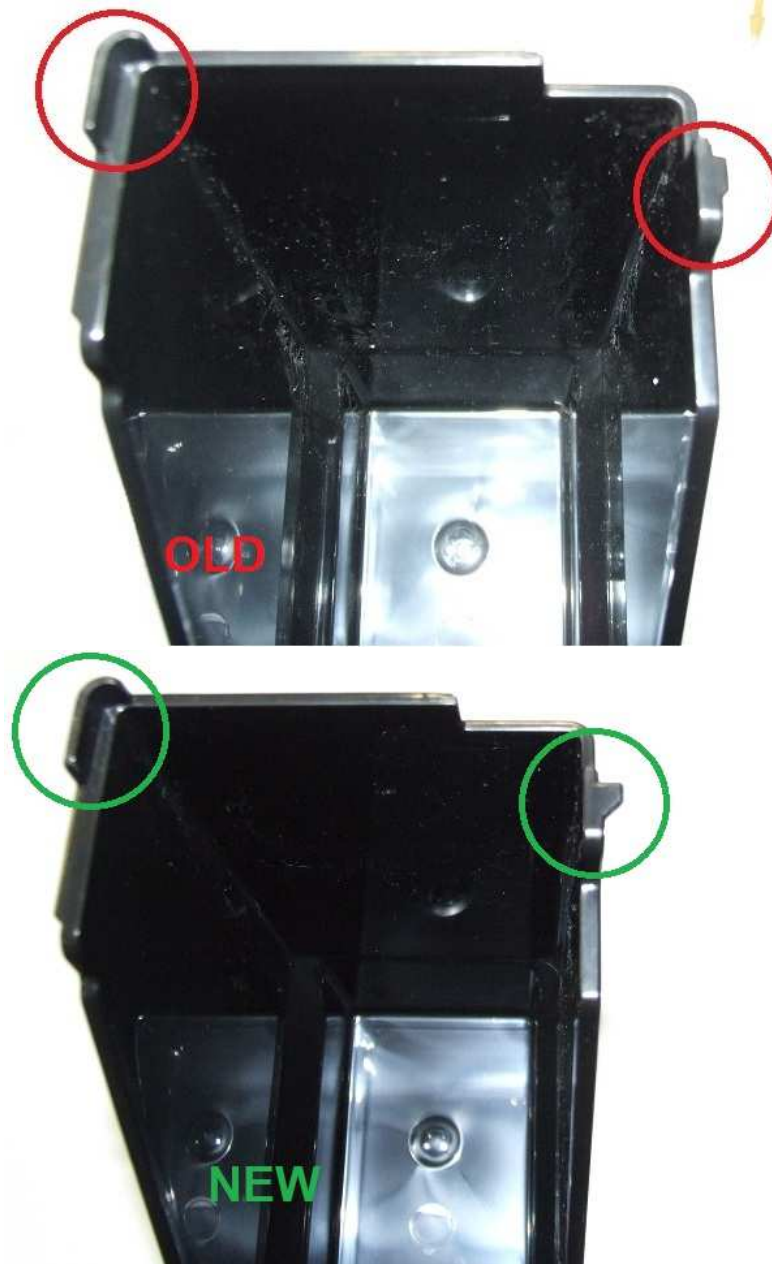
INFO:The Microswitch on drip tray was activated accidentally. To avoid the incorrect activation of the microswitch, the design of two upper flaps on the dump box has been changed as shown in the picture NEW on the right. This technical change on the dump box enabled the proper activation of the Microswitch on drip tray.

CURE:The improvement has been introduced in production by WK43. **Order the new code 421944060591 BLK DUMP BOX V2 SMR.**
