Service information

Reference no.: SDA_111962

MANDATORY CHECK: verify the correct position of the Air stop in all repairs for Incanto and Gaggia Anima machines

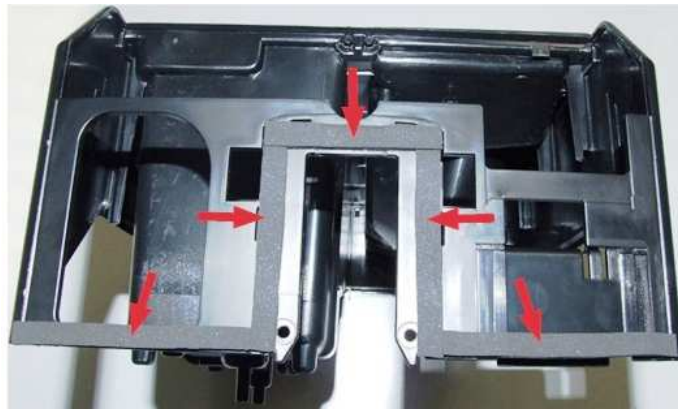
Image1

Up to SN: TW901550690343 the machines were assembled with five pieces of 'Air stop*', to prevent humidity going into the machine. It could happen that the position of the 'Air stop' is not ok (gaps between separate pieces) and humidity can pass through. This can cause display malfunctioning or short-circuit on the CPU board, which in turn generate other defects such as switching thermostats.

1. Check the correct positioning of the air stop at each machine (Up to s.n. TW901550690343). Correct positioning without gaps between the single pieces is shown in below (Image1).
2. If there should be gaps between parts of the 'Air stop' or if it should be damaged / missing, replace it by cod. 421944063091 WHT ADH.AERSTOP UPP.CAS.COV.SMRG (Image2)
