Service information

Reference no.: SDA_112371

Leaking coffee between the spout and the front cover in Pico Baristo

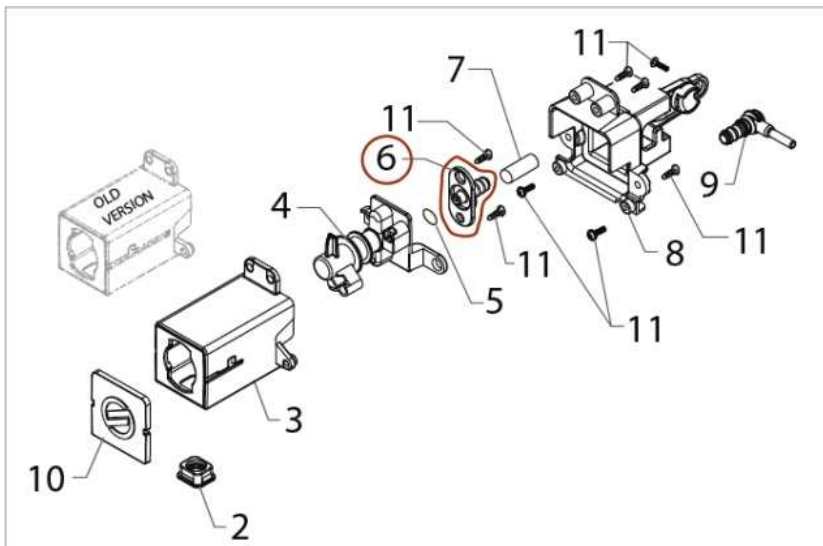
INFO:
Leaking coffee between the spout and the front cover out of the casing below the coffee dispenser. Inner coffee dispenser is wrong assembled. The dispenser connector (exploded view position 6 - Image1) was assembled with 180° rotation. Because of the different sizes of the whole the connection doesn't fit correctly and isn't tight. (Image1)

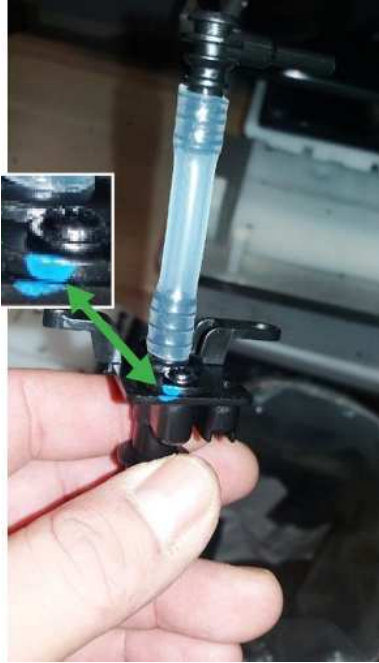
n the assembly

to state the check of the assembly.
(Image3)
