**Service information**

**Reference no.: SDA\_112764**

Mandatory Action: Insert the rubber cover for water sensor in all repairs for Minuto, Incanto and Pico Baristo.

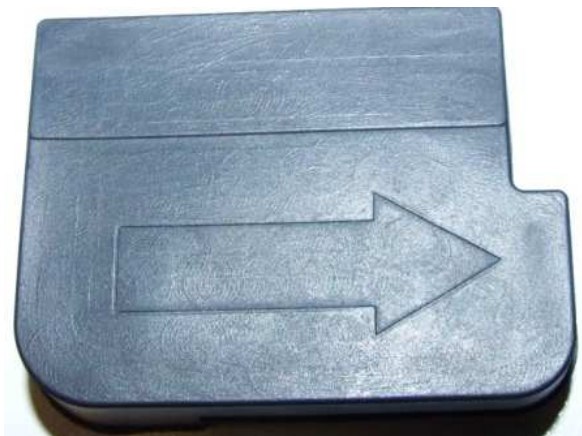
The humidity cause the wrong reading of the capacity sensor therefore the water tank alarm pops up suddenly.

Code of rubber cover: 421944006871 GRY WATER LEVEL SENSOR COVER SMR (Image1)  
Image 1

Insert the rubber cover proceeding as shown in image2 in all Minuto, Incanto (Minuto based) and Pico Baristo **up to:**
