Service information

Reference no.: SDA_113412

Mandatory Action: Insert a seal between the lids in all repairs for Minuto family machines.

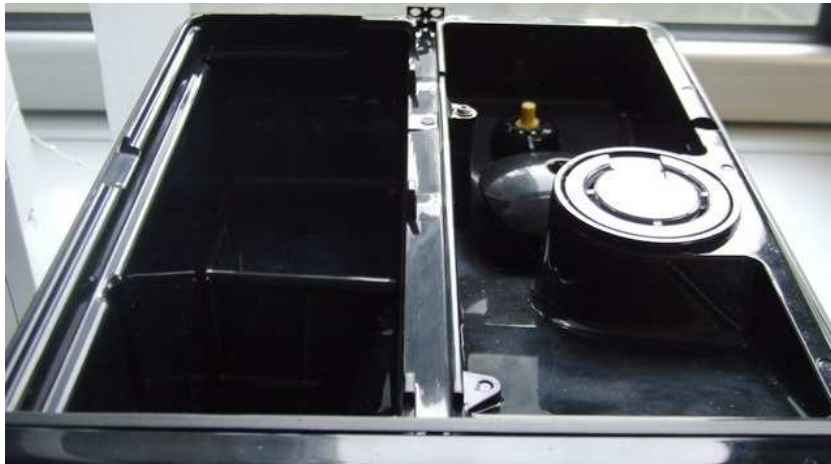
Image1

In all Minuto machines a seal has been inserted between the lids to avoid that water can invade the coffee container,

Insert mandatorily the seal, code 421944067611 "BLK SEAL CONT.LIDS SMRG", between the lids as shown below:
