Service information

Reference no.: SDA_113777

Coffee leaking from Coffee Dispenser Body – Philips 4000

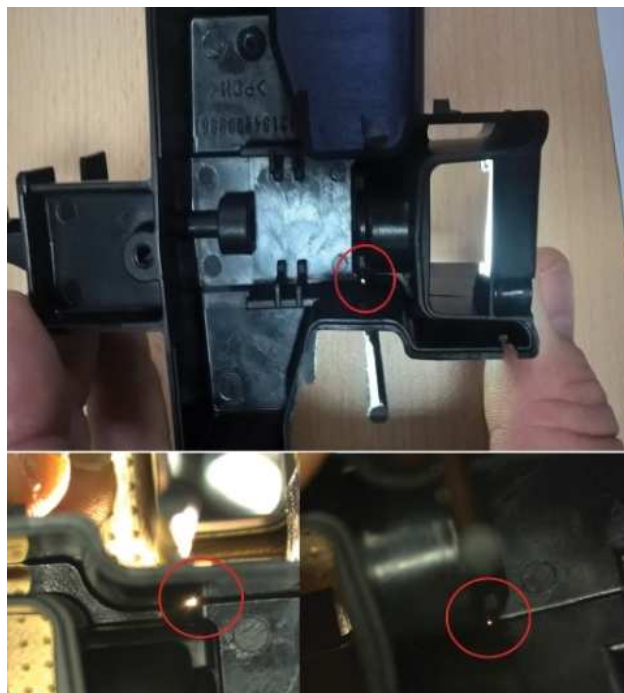
Image 1

Cure: From S.N TW901612171214, the mold of the Coffee Dispenser Body of Philips 4000 was changed because there were holes (Image 1) which could cause leakage of coffee. The new components are also recognizable from the time stamp (Image2).

Action: Up to S.N TW901612171213 in the case of leakage due to the described issue, replace the component 421944039951 BLK COFF.DISP.BODY SMRA

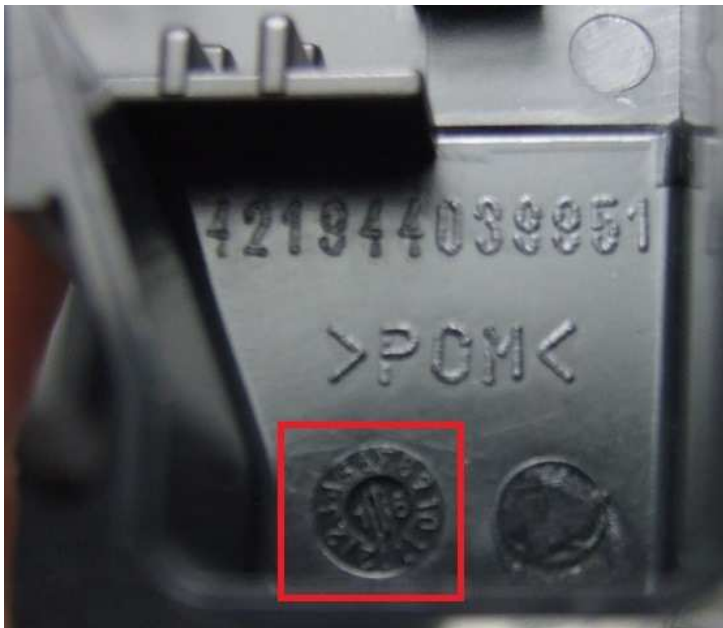
Image 2

The new components can be identified by the time stamp (Image2). Improved parts do have a stamp of: **Year 16 Month 06 or newer**. Do not use parts with an older time stamp (double check in case you should use cannibalized parts).
