Service information

Reference no.: SDA_114084

Slipping off water sensor wiring

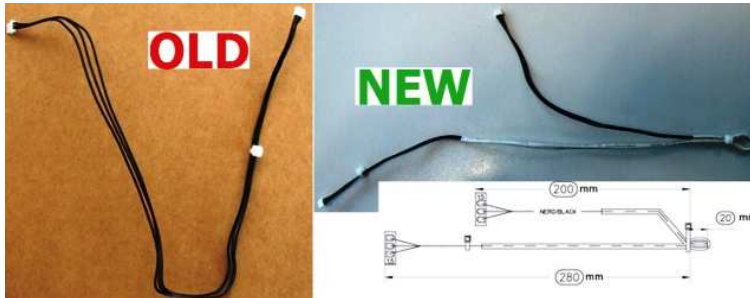
Symptom:
Alarm for empty water tank remains always on.

CURE:
Wiring was improved to avoid that the plug of water level sensor is disconnecting from CPU board.

Actions:
In case the plug was disconnected, replace the plug by the improved version and refit it proceed as shown in following images.
