## Service information

Reference no.: SDA\_114129

Conveyor clogged and presence of the coffee powder inside the service door for Xsmall, Philips 2000 and Philips 2100

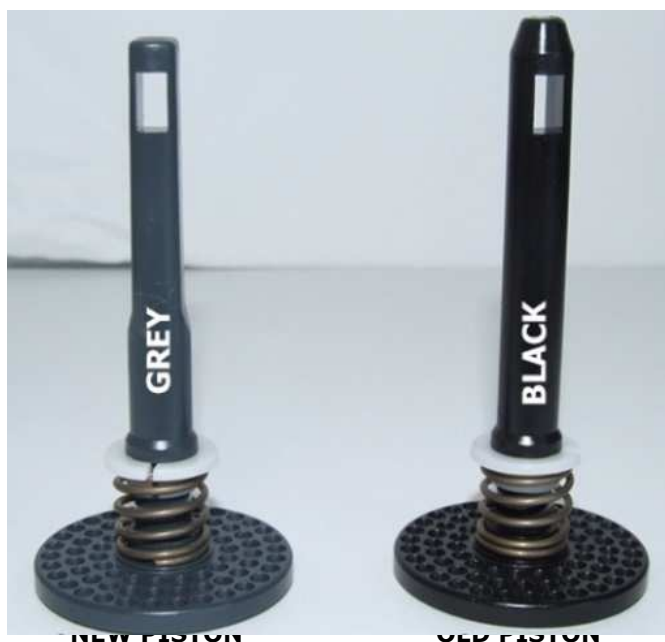
Image1

- Brews no coffee;
- Only clear water comes out of the dispenser;
- Grinder works but it throws no powder into the brew unit;
- Conveyor clogged;
- Presence of coffee powder and water in the brew unit compartment;
- The piston is in high position even when the Brew Unit is in home position (the brew unit wasn't maintained by the consumer).

1. reduce the splashing of water that wetting the coffee powder, this is fixed to the conveyor walls causing its clogging;
2. improve the discharge of residual water on the drip tray after coffee has been dispensed;
3. improve the sliding of the piston even in case of lack or poor maintenance of the Brew Unit.

- A) Up to S.N. TW901546609697 **clean and grease** the old piston (Image1);
- B) From S.N. TW901546609698 **replace** the piston with new one (Image1).
