Service information

Reference no.: SDA_76318

Intermittent power while using the product.

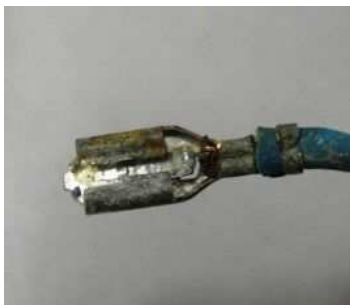
Figure 3: Heat sink paste at L & N connections

Step 3: Upon re-assembly, apply heat sink paste at the connections. See Figure 3.
