Service information

Reference no.: SDA_76872

Steam not coming out from one side of soleplate

Applicable for : GC2810, GC2820, GC2830, GC2840, GC2860

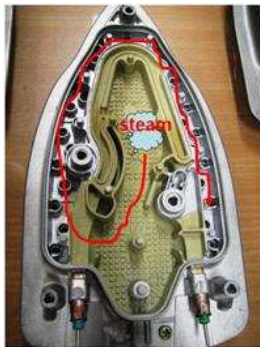
Symptom: Consumers claim that no steam is coming from the left side holes at the soleplate; steam is only coming from the holes on the right side.

As shown in path (see red line), steam is directed from one side of the soleplate. This maximizes the steam amount boost in shortest amount of time. However, in vertical refreshing, steam is seen visually coming more from one side of the soleplate.

Cure:
Not applicable. Design feature

To prevent future negative perception, it is advise that in demonstrations, it is advise to demonstrate vertical steaming with the iron always pressed against the garment.
