Service information

Exhaust grille is hard to mount

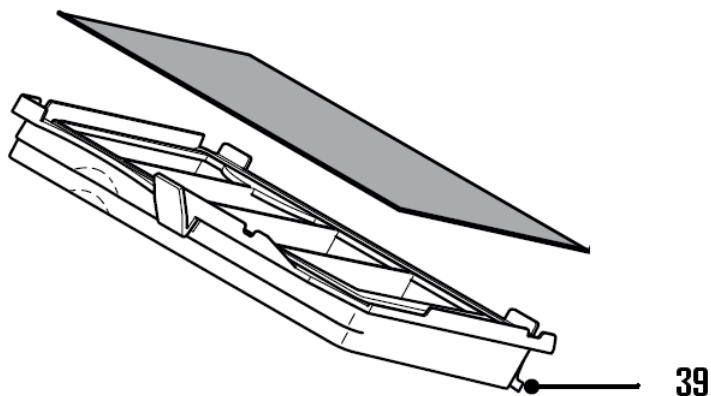
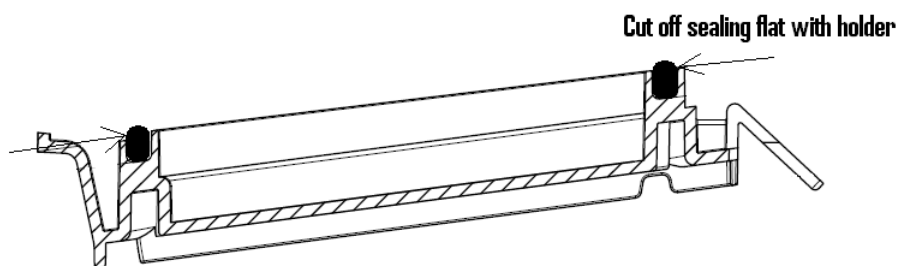
INFO: After some complaints it was found that due to too much sealing material used in the AFS filter support (Pos.39) there is too much tension on the Exhaust grille, causing it to pop out

CURE: Please replace AFS support 432200518070, this should solve the problem. (PS. problem will also solve itself, after some use/heating up the sealing will adjust itself) Optional soluti

below)
