Reference no.: SDA_81288

Service information

Symptom

Soleplate does not heat up.

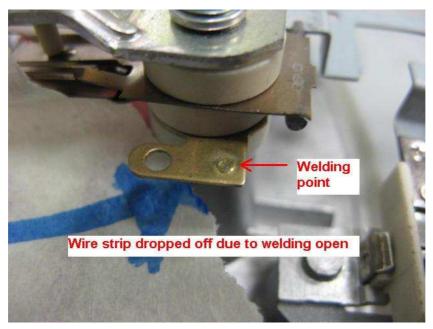
Welding open at thermostat assy:

INFO:One possible root cause is detached spot welding points on the wire frame connectors. The welding point can open due to product

drop or poor welding.

Open welding point can happen at the thermostat assy or at the heater pin. Refer below pictures.

CURE:For service repair, please replace the complete soleplate assy. It is not possible to do the welding at service center because specialized equipment & process control is required for the spot welding process.
