Service information

Reference no.: SDA_81290

Ironing plate detached from soleplate.

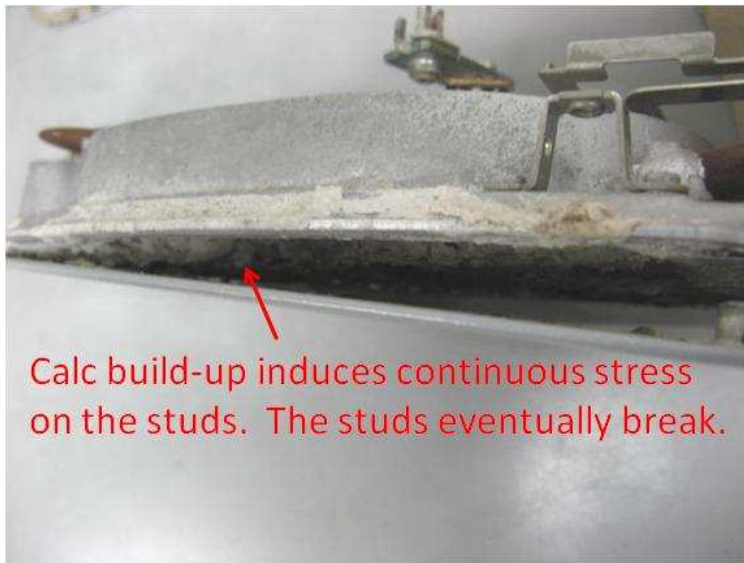
Absence of regular calc cleaning can lead to calc accumulation within the soleplate. Continuous calc build-up induces increasing stress on the ironing plate studs which eventually give way. Once the studs are broken, the ironing plate is detached from the soleplate.

1. Service center to advise consumers for regular calc cleaning to prevent calc build-up. Users can refer to user manual or Philips support website regarding how to carry out calc cleaning.
2. Service centers to carry out soleplate calc cleaning before returning the product to users, regardless of the complaint.
3. If service centers detect visible gap at the ironing plate, to replace the soleplate assy preemptively.

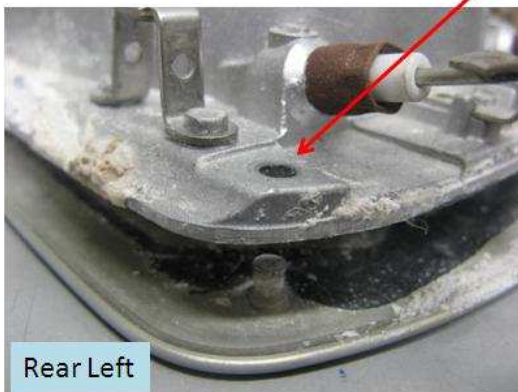
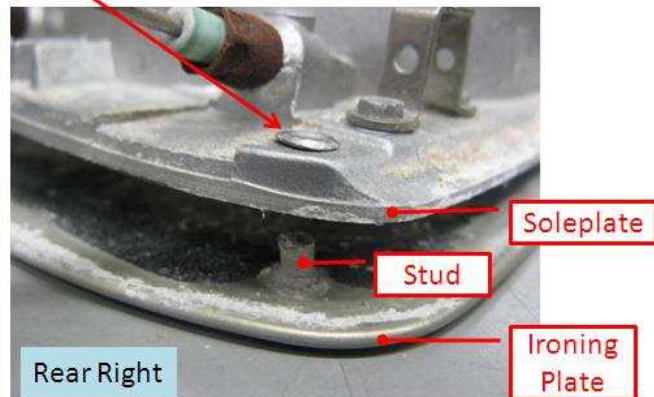
Stud rivet head broken
