Service information

Reference no.: SDA_89982

Mandatory - No communication between CPU and grinder sensor, grinder sensor wiring in wrong position

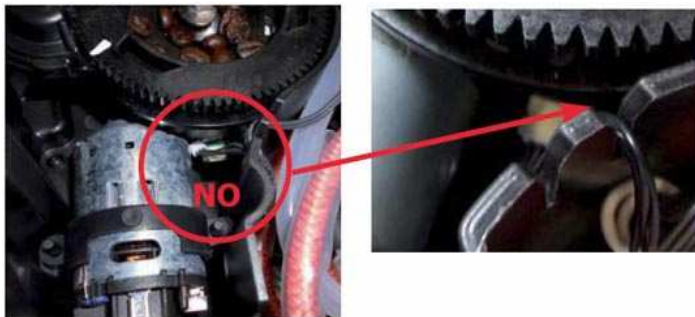
Image 1

1°Problem : for incorrect positioning of the sensor wiring the grinder sensor is unplugged.

If the grinder sensor wiring is positioned like the pictures below (Image 1) :

Solution for the first problem: change the position of the grinder sensor wiring .
