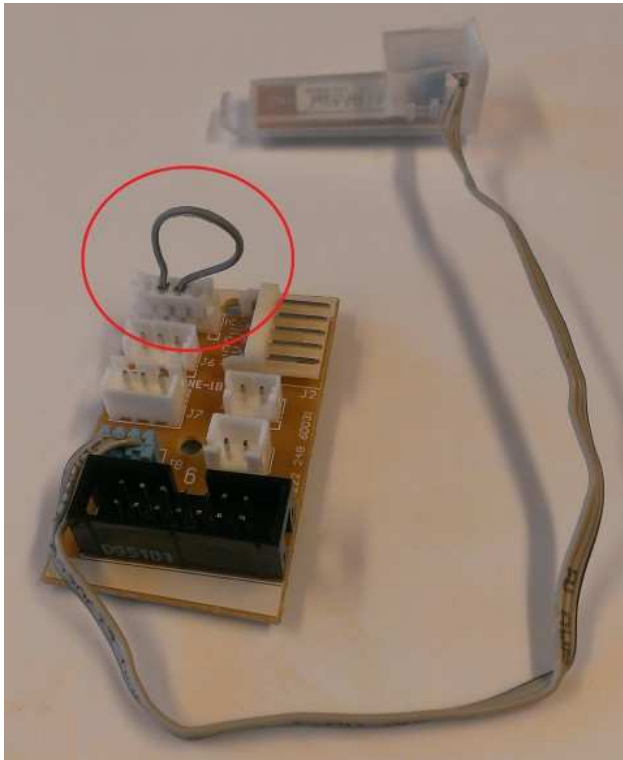
please remove it, as interference can still accidentally trigger the two-cup button. The header on the interconnect PCBA must remain empty!
