Service information

Reference no.: SDA

GC92xx, GC95xx water tank leaks

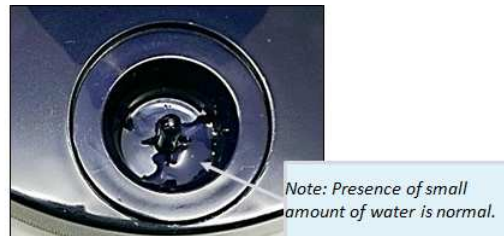
Symptom : Water tank leaks

- When water tank is engaged to the product, water leaks from water tank seal.
- After some time, water accumulates at the water socket and overflow.

Water tank seal deformed or torn when engaging water tank to the appliance.

1. Insert inlet tube (12NC:4239 015 60881) fully into the socket pin.

2. Replace the water tank Assy if the seal is torn or damaged.
