Service information

GC240 Ironing board - Shoulder wing loose

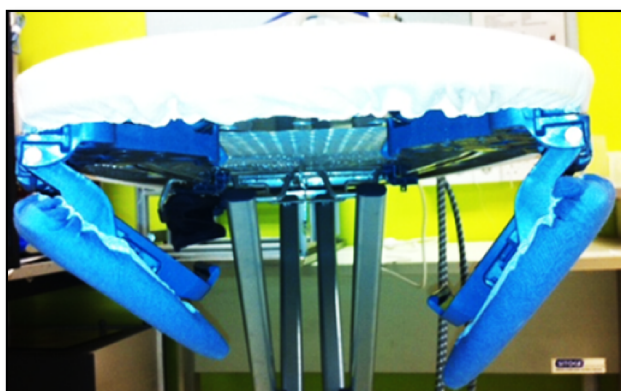
Symptom: Shoulder wing not able to lock tightly.

The wing engagement becomes loose due to plastic part warpage.

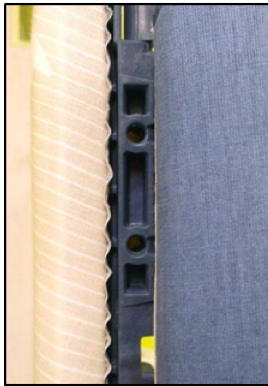
Before

Front view

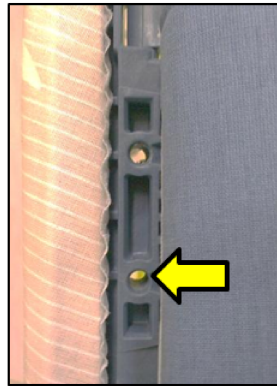
After

Result after drilled through.

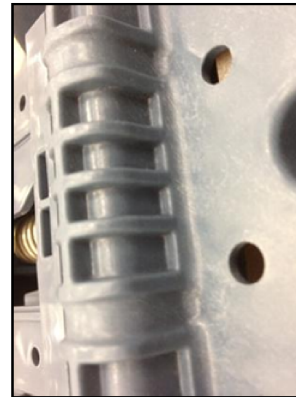
Before

Rear view
