Service information

Reference no.: SDA_96170

Improvement of the brew unit lubrication.

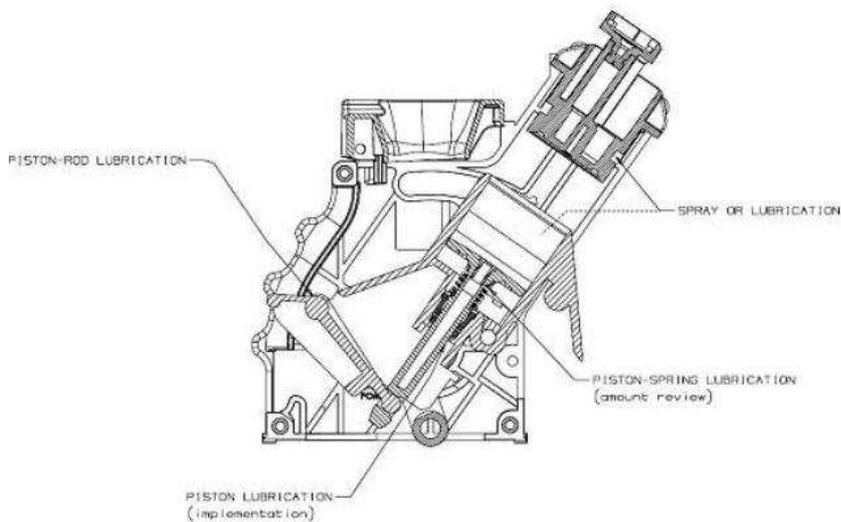
The condensation present in conveyor cone due to the usage of the machine, capture part of grinded coffee powder and start a process of reduction of hole of conveyor that continues in next grinding and brewing cycles until conveyor become completely clogged by wet and dry coffee powder.
In some case you got a watery coffee while in other cases the grinder assy become completely blocked and relative alarm raised by the machine.

The general action consists in a lubricate of the brewing unit parts (Image1), mainly focused in the piston rod (Image2) to ensure the correct sliding on the gasket to avoids eventual water splashing that might cause deposits of ground coffee at the exit of the conveyor.

For internal order cod. 11028379 KLUBER TUBE 5GR.
