Service information

Reference no.: SDA_96288

Improvement assembly teflon tube and plastic support

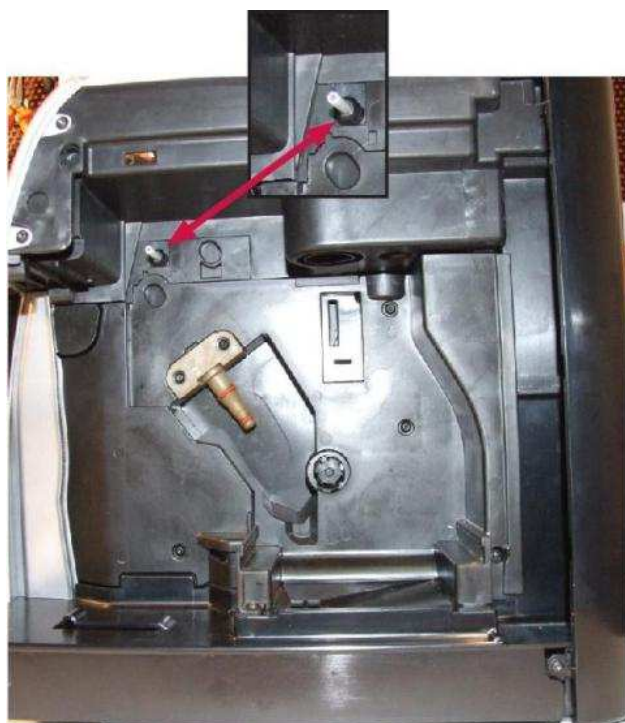
Image 1

Possible damage of teflon tube or black plastic support (indicated in the image 1).

The assembly device of the teflon tube with plastic support used in production was not correctly calibrated and so could cause the damage of one or both the plastic fixing "wing". Consequently the assembled part can get broken during the insertion of the brew unit.

Replace the damaged component cod.11005101 with a new one.

From serial number TU901230122604 the assembly device has been checked and calibrated to ensure the correct assembly of teflon tube and plastic support.
