Service information

Reference no.: SDA_97068

Tophousing is deformed and/or button is melted

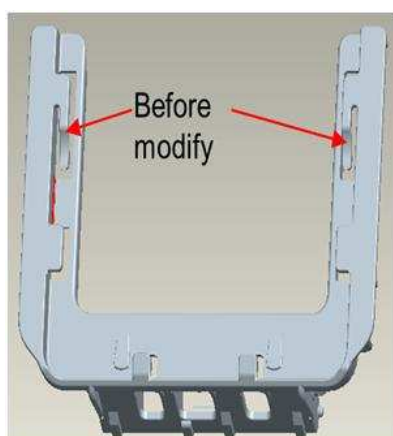
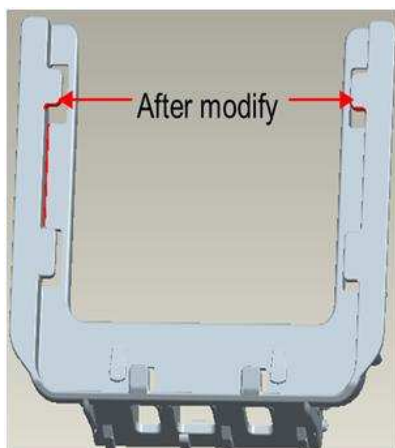
Symptom:
Tophousing is deformed and/or button is melted

INFO:
Blockage because of dirt in the Dustchamber, motor gets overheated and housing and/or button will melt

CURE:
Change the Dustbagholder to guarantee that dust will not block the airflow and motor will not get overheated anymore.

Remark:
Implemented in production per 1-1-2013
