Service information

Reference no.: SDA_97593

1W and 0.5W Power Board and Control Board

Products affected: GC82xx, GC83xx

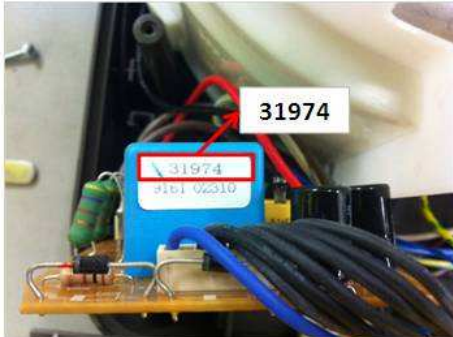
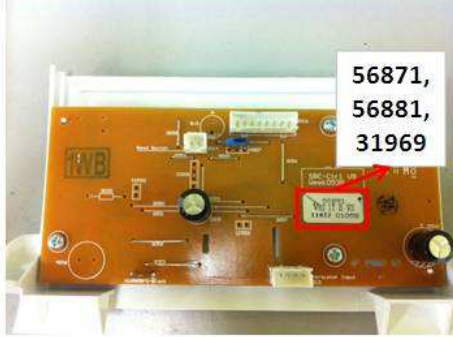
| | Power Board | Control Board |
|---|---|--|
| OLD | | |

To identify OLD/ NEW Power Board and Control Board:
