**Service information**

**Reference no.: SDA\_98312**

Appliance switches off by itself during ironing or turns on immediately when plug-in to wall socket

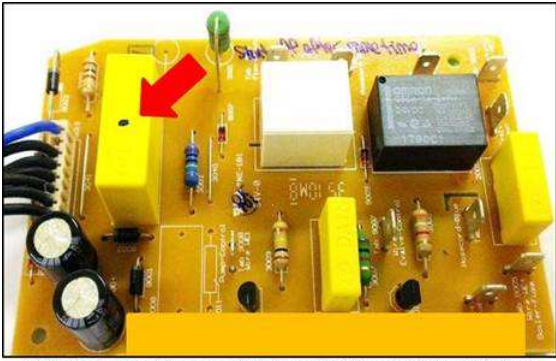
Component reliability issue: Power board PCBA - Capacitor degraded overtime when appliance is always plug in on the wall socket even when not in use.

Affected capacitor for GC73xx,GC74xx,GC75xx,GC83xx

Replace the degraded capacitor with new capacitor. Refer to the repair instruction and details shown below for different products affected.

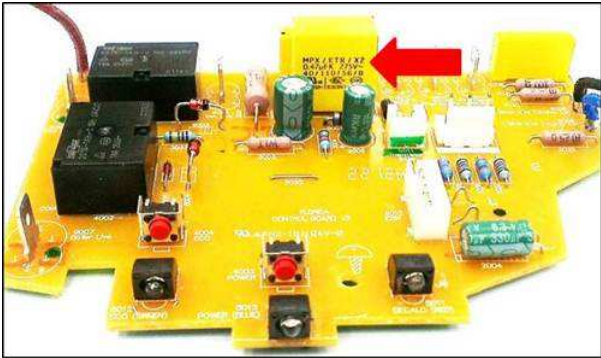
Affected capacitor for GC86xx

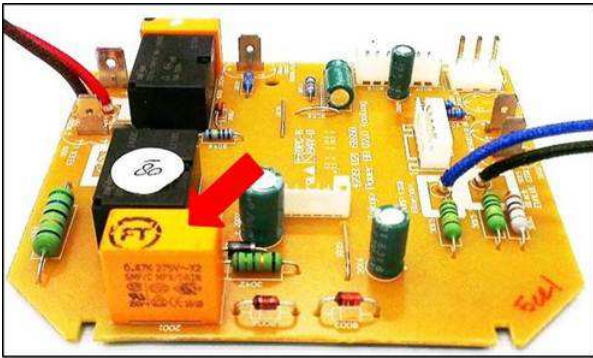
Affected capacitor for GC92xx & GC95xx
