**Service information**

**Reference no.: GDA\_104726**

Additional seal found in boiler assy.

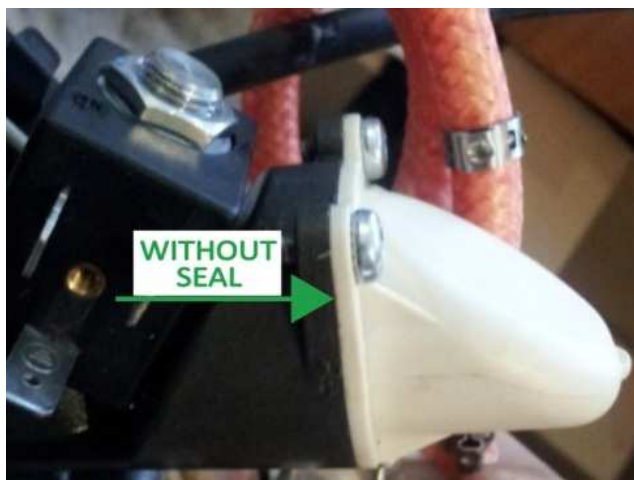
INFO:  
From S/N TU901342179781 in the Piston Unit Assy a seal has been inserted in order to improve the boiler assy.  
In Image 1 you can see the Piston Unit without seal.  
In Image 2 you can see the Piston Unit with seal.  
Both versions can be used for repair.
