**Service information**

**Reference no.: GDA\_109438**

Leakage from boiler pin connector

**INFO:** Attn. to: Service center leaders  
Subject: Minuto boiler pin connector leakage  
(code 17000727- 996530073427) 421941279741

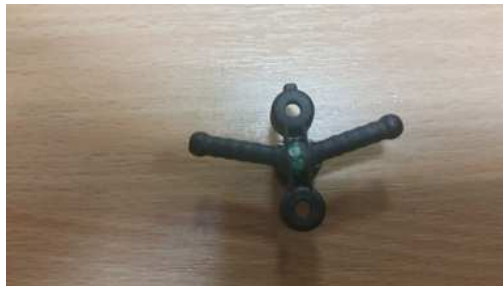
Hereby we want to inform you about the leaking Minuto appliances caused by a design issue related to the boiler pin connector (part no xyz, see picture 1).

The service center engineer must replace the failing connector with a new part which can be recognized from the green dot present on the center dimension of the connector (see picture 1). Boiler pin connectors without the green dot cannot be used and have to be immediately sent back to the Spare Parts department. They will reintegrate the stock according to the quantity received.

All parts in stock are to be immediately returned back to the SP department since using those will potentially lead to reoccurrence of the leakage issue at the end-user during a period of normal use. The stock will be reintegrated accordingly to the parts received.
