Service information

Reference no.: GDA_112263

Localized peeling of spray paint at the Tray for GC9642 only

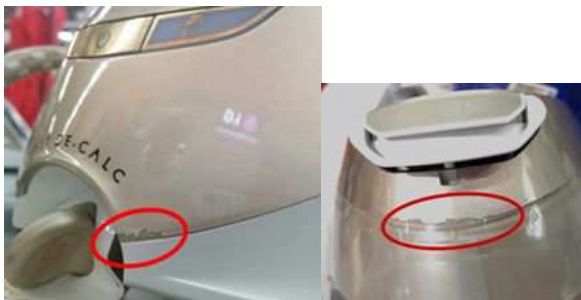
Localized peeling of the spray painted tray (resulting in aesthetic issue) of GC9642 PerfectCare Elite Steam Generator. The defect does not affect any of the product functionality.

The consumer will notice that paint might peel at the edges of the tray as shown in the picture below:

1. 100% tape test screening in Production. Implemented in Production in Wk1545.
2. New primer is introduced to improve paint adhesion. Implemented in Production in Wk1549

Iris code to be used when replacing the Peeling off Painting tray for GCS data tracking . These code must be used.

symptom code= 16E, Section code=G47, Defect code = H, Repair code = H
