**Service information**

**Reference no.: SDA\_101740**

DAMAGE OF KEYBOARD ON GRAN BARISTO REPAIR

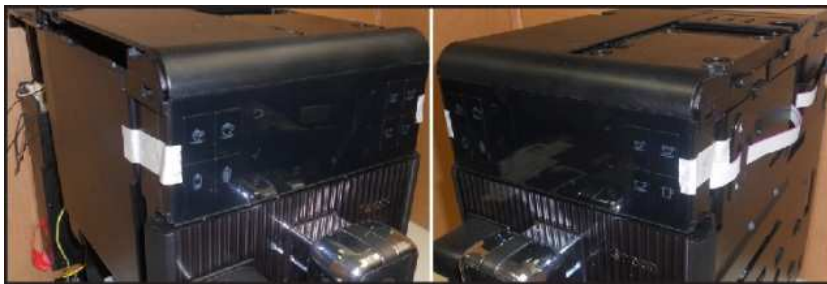
Image 1

**CURE:**  
Every time that it's necessary to access inside the machine, after removing of the two lateral panels, the capacitive keyboard must be fixed on the appliance sides with paper adhesive tape, as shown in the image 1.

Now it's possible to remove the top cover and make the necessary repair.  
Remove the tape only after re-assembly of top cover, before re-insert two side panels.

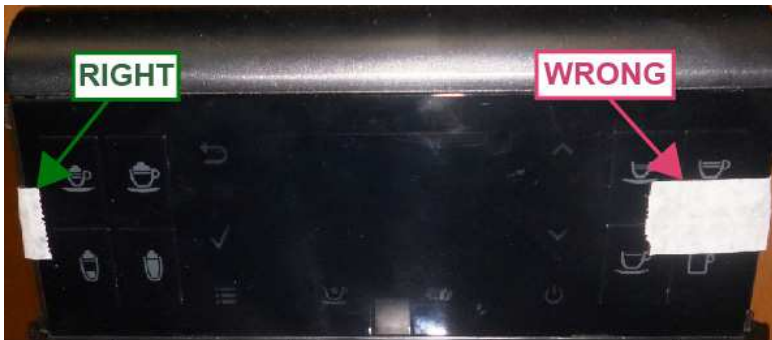
Image 2

**NOTE:** Take care to not cover keyboard with the tape (see in Image 2).
