Symptom

Vibrating plate does not vibrate properly.

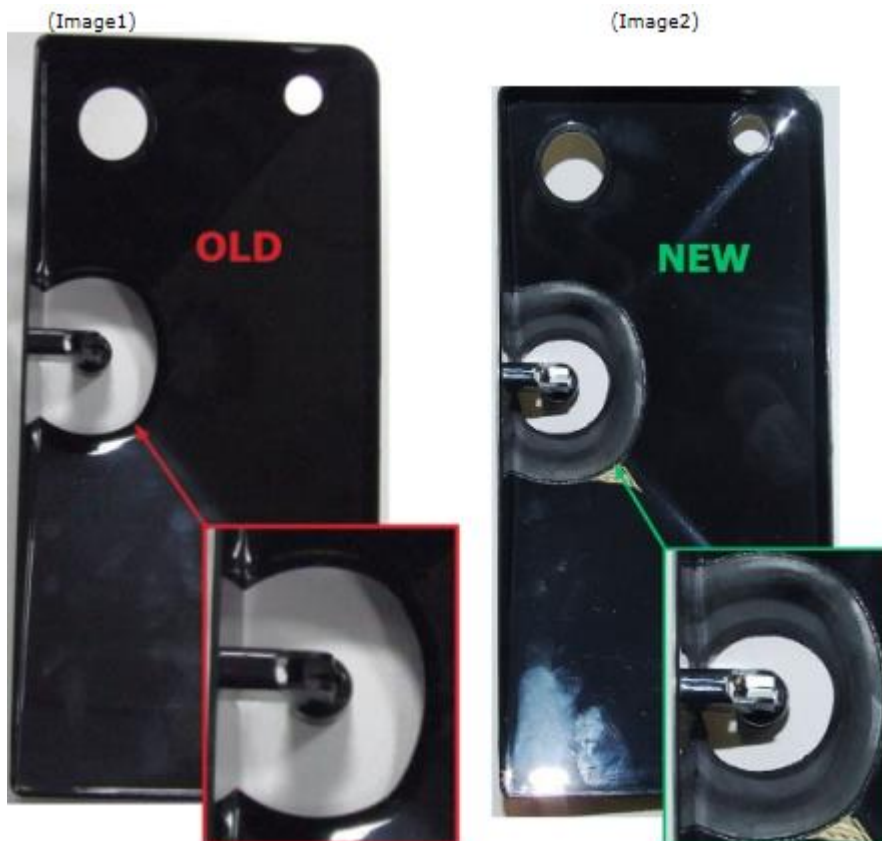
From **SN TU901431108216** we have introduced a molded seal to prevent beans from sliding below the bean container. Image 1 - 2

Actions: For affected machines (**up to SN TW901525318496**) order both:

- Bean Container: code 421944052791 BLK ADDITION.BEAN CONT.COST.V5 HGO ASSY (Image3)
- Bean Container Inlet: code 421940813151 KIT SPARES BLK REMOV.COF.CONT.HGO ASSY. Image4)

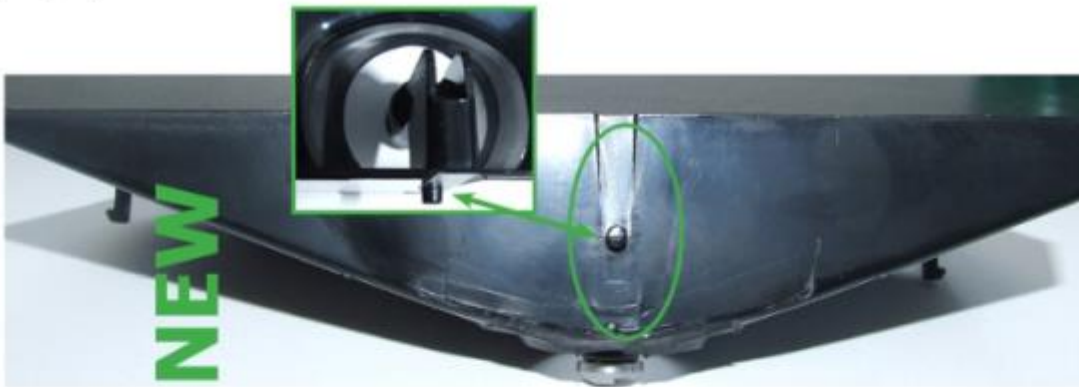
From **SN TW901525318497** the bean inlet is having a pin to improve the vibration. (Image 3)
