Service information

Reference no.: SDA_109307

White Support boiler in GranBaristo family.

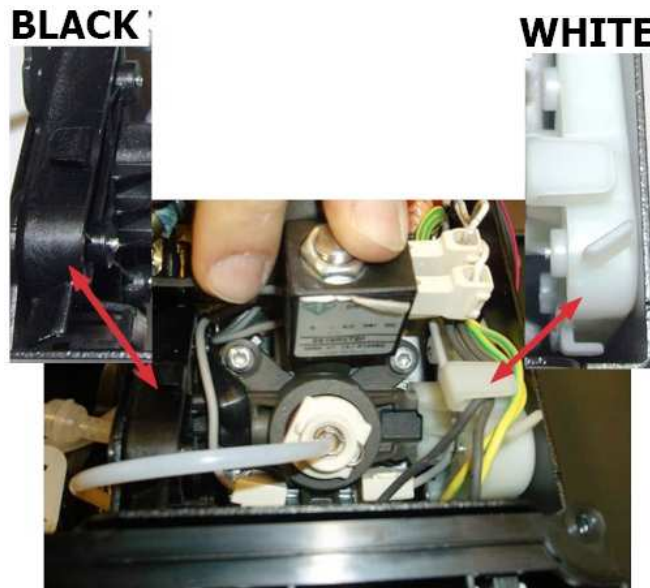
INFO:From serial TU901446163585 you may see the white boiler support (Image1). It has been temporarily introduced to counteract the premature wear of the piston seals.

In case of replacement the support of white color order cod. 421944032332 NEU PISTON UNIT UPPER PART SUPP.V3 CST
