Service information

Reference no.: SDA_109625

White Support boiler in GranBaristo family.

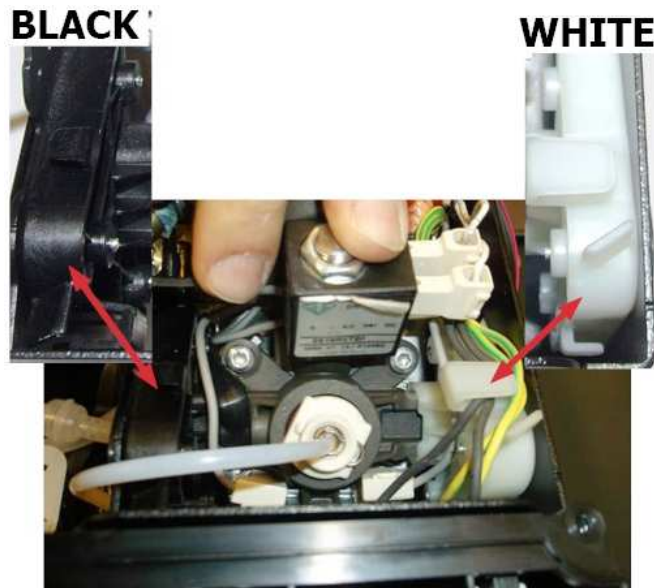
From s.n. TU901446163585 to s.n.TU901510056621 you may see the white boiler support (Image1). It has been temporarily introduced to counteract the premature wear of the piston seals.

From s.n. TU901446163585 to s.n.TU901510056620

To replace the white support order only the cod. 421944032332 BLK PISTON UNIT UPPER PART SUPP.V3 CST

To replace the black support order only the cod. 421944032331 BLK PISTON UNIT UPPER PART SUPP.V2 CST

The 2 parts cannot be switched.
