Service information

Reference no.: SDA_109957

Mandatory Action: Insert the separator between coffee bean and water container in all repairs for Minuto family.

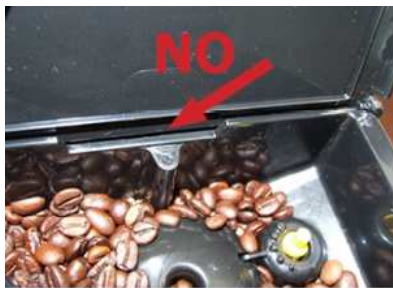
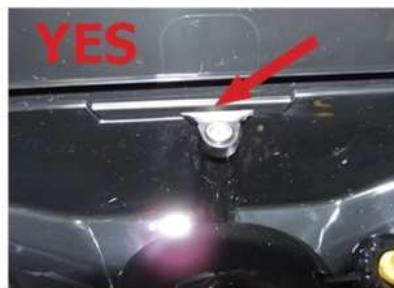
(Image1)

In the Minuto family from s.n. TW901511152955 a separator was inserted to prevent that coffee beans falls into the water container.

If it should not be present, insert the separator in all machines. (Image1 – NO: without YES: with separator)
