Service information

Reference no.: SDA_110566

MANDATORY ACTION: GC76xx Hose Cord Assy Improvement

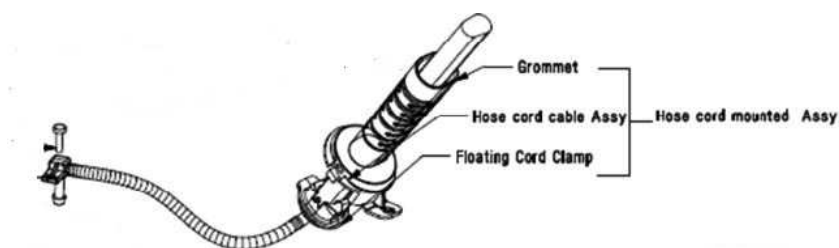
Info: New hose cord is implemented in production from 1450 till 1502 as per transition period. From wk1502 onwards, all sets are using improved part.
