Service information

Reference no.: SDA_111053

New SW for GranBaristo Avanti, Mid and Base.

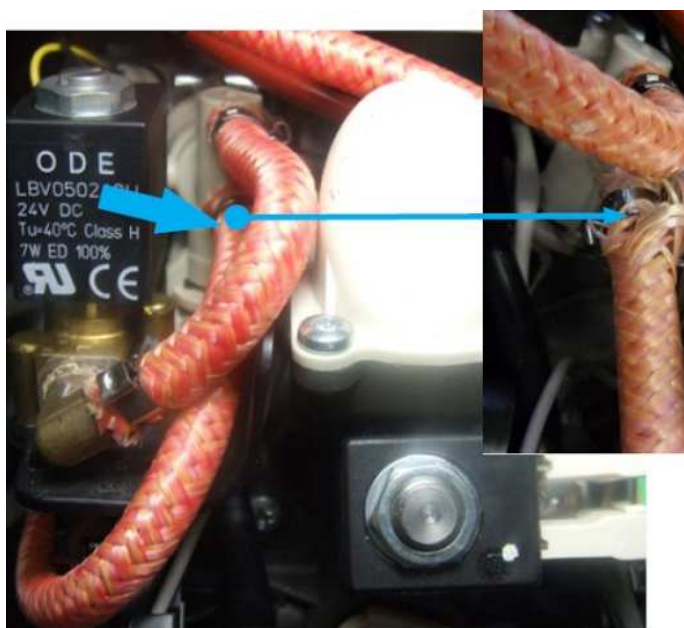
To avoid breaking of the tube, as shown in Image 01, a new SW has been released. It was decreased the time in the pre-load of the products, to reduce the excessive pressure generated in the hydraulic circuit, maintaining the amount of doses of the product unchanged.
Image01

Up to s.n. TU9015240068963 inserted the new SW
Gran Baristo AVANTI SW.06.03.10
Gran Baristo MID SW.02.07.10
Gran Baristo BASE SW.01.07.10
