Service information

Reference no.: SDA_112059

Loss water, from the solenoid valve of Granbaristo.

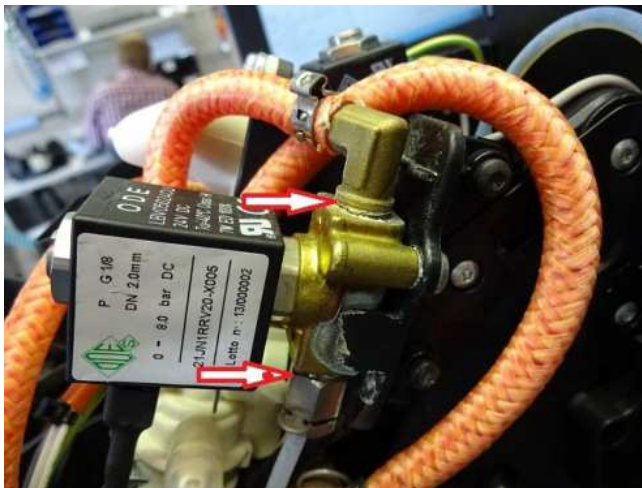
To avoid leakage due to incorrect assembly of the solenoid valve on GranBaristo (Image1), only the solenoid assembly will be available.

Order the cod. 421944033041 SOLENOID VALVE V2 CST 24V ASSY (Image 2).
